WA-I-013

National Register of Historic Places Registration Form

historic name Kammerer, Johann Ludwig, House

CONTINUATION SHEET 1
NARRATIVE DESCRIPTION*Overview*

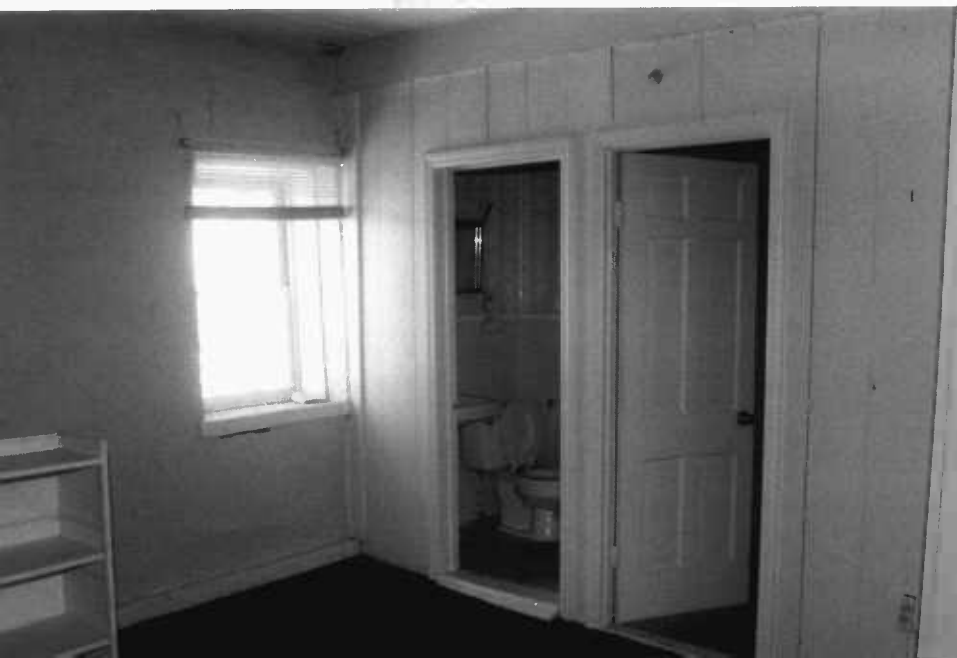
WA-I-13

nd floor landing looking towards west side
... ..

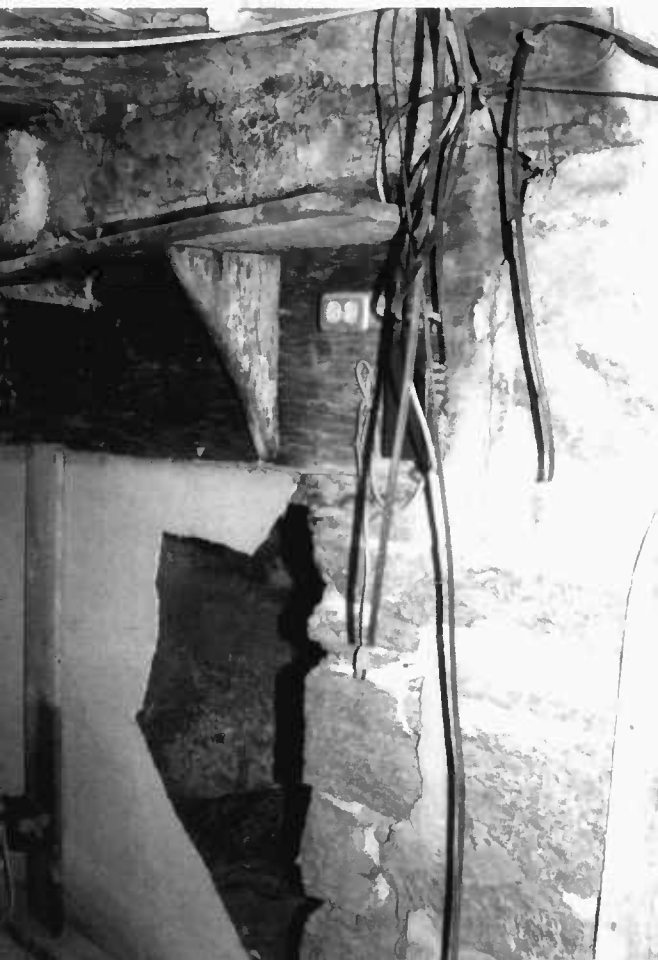
WA-I-13

Cellar Storage

The cellar is probably the most intact and significant area of the Kammerer House. It is accessed from a ground-level entrance on the west wall or by the stairs in the southwest corner of the küche. (A later entrance was added on the north wall.) The cellar also follows the flurkuchenhaus plan, with both entrances leading into the küche. Here there is a large stone service fireplace, with a massive timber framing the top of the opening. To the right of the fireplace is an arched storage alcove that supports the mass of masonry above. Opposite the fireplace is a window.

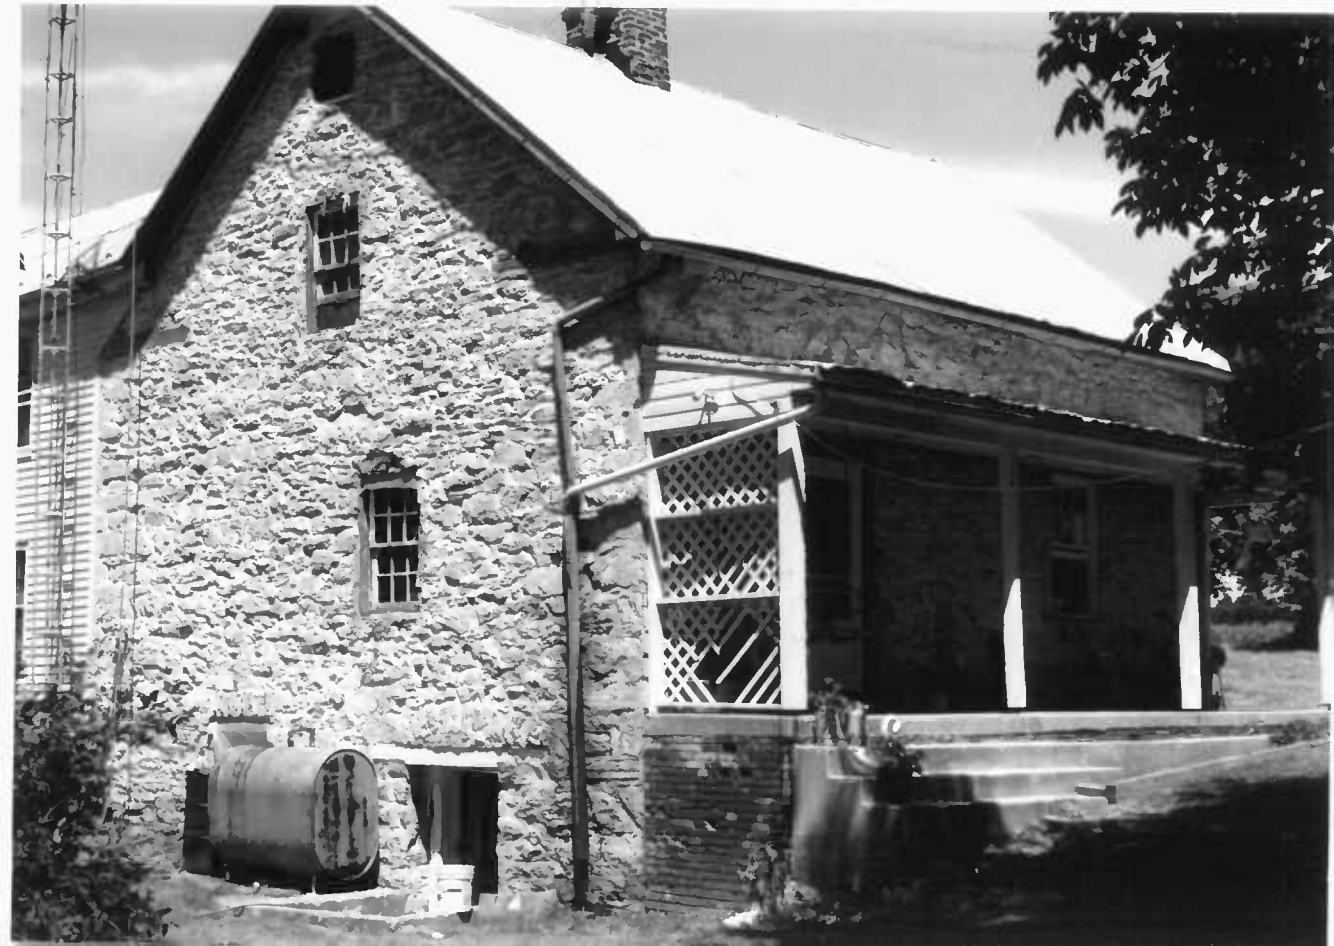
WA-1-013

Kameron's Stone House
From southwest

The front of the Kammerer House faces south. It has a door in the west bay and a window in the east bay. A shed-roofed porch with wooden posts, two square and two chamfered, extends across the entire front of the house. The porch now has a concrete deck and steps and rests on a brick foundation. The window has six-over-six panes set within a narrow frame. The frame is a replacement, dating from the mid-19th century or later. Disturbed masonry around the window indicates that the window was altered as part of the frame replacement. The door is the main entrance to the home. The out door jamb appears to be original, but the door itself is an early 19th century replacement. The door has two vertical panels with the raised portion of the panels having curved oval segments cut in each corner. This design feature is usually associated with the 1810s and 1820s

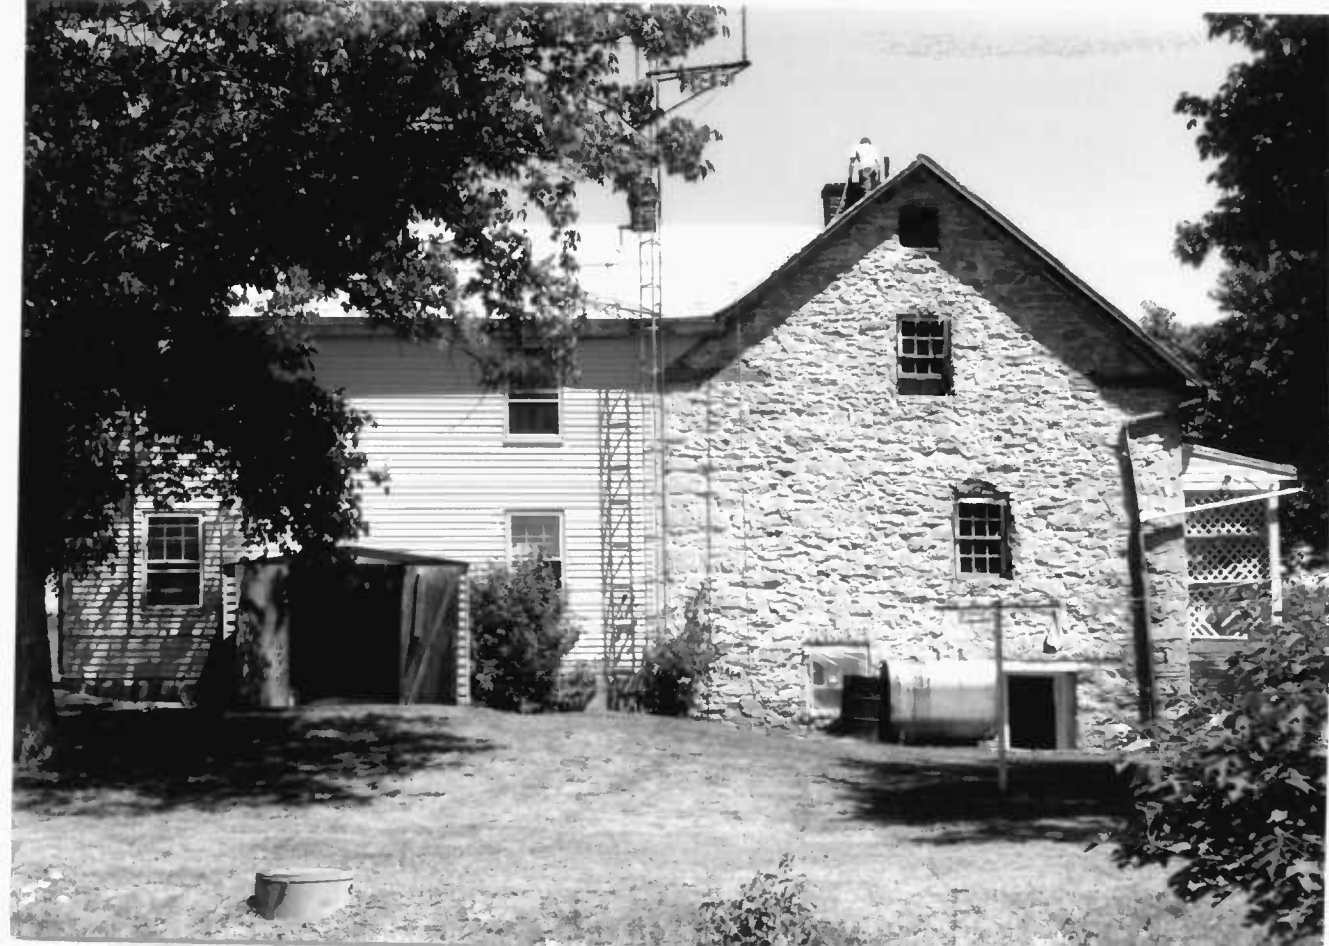
WA-1-013

Kameron's Stone House

From west

The west elevation of the house has openings on four different levels: the cellar, the main story, the upper floor, and the attic. None of these openings align with each other. At the cellar level, there is a door and window. The window has an original frame, which is a wide, mortised and tenoned, pegged structure. The sash has been replaced. Above the window is a flat arch of stone. Next to the window, the cellar doorway is topped with a segmental arch of stone. The opening appears to have been modified, because a wide wooden lintel extends through the stone work well beyond the width of the opening on both sides. Also, the arch does not align with the current opening. On the first story is a single window placed towards the front of the house. It has a six-over-six pane sash within a narrow replacement frame. The second story also has a six-over-six window that has been replaced. A small window is nestled at the peak of the gable to light and ventilate the attic. Another 18th century feature worthy of note is the pair of very long returns at the gable.

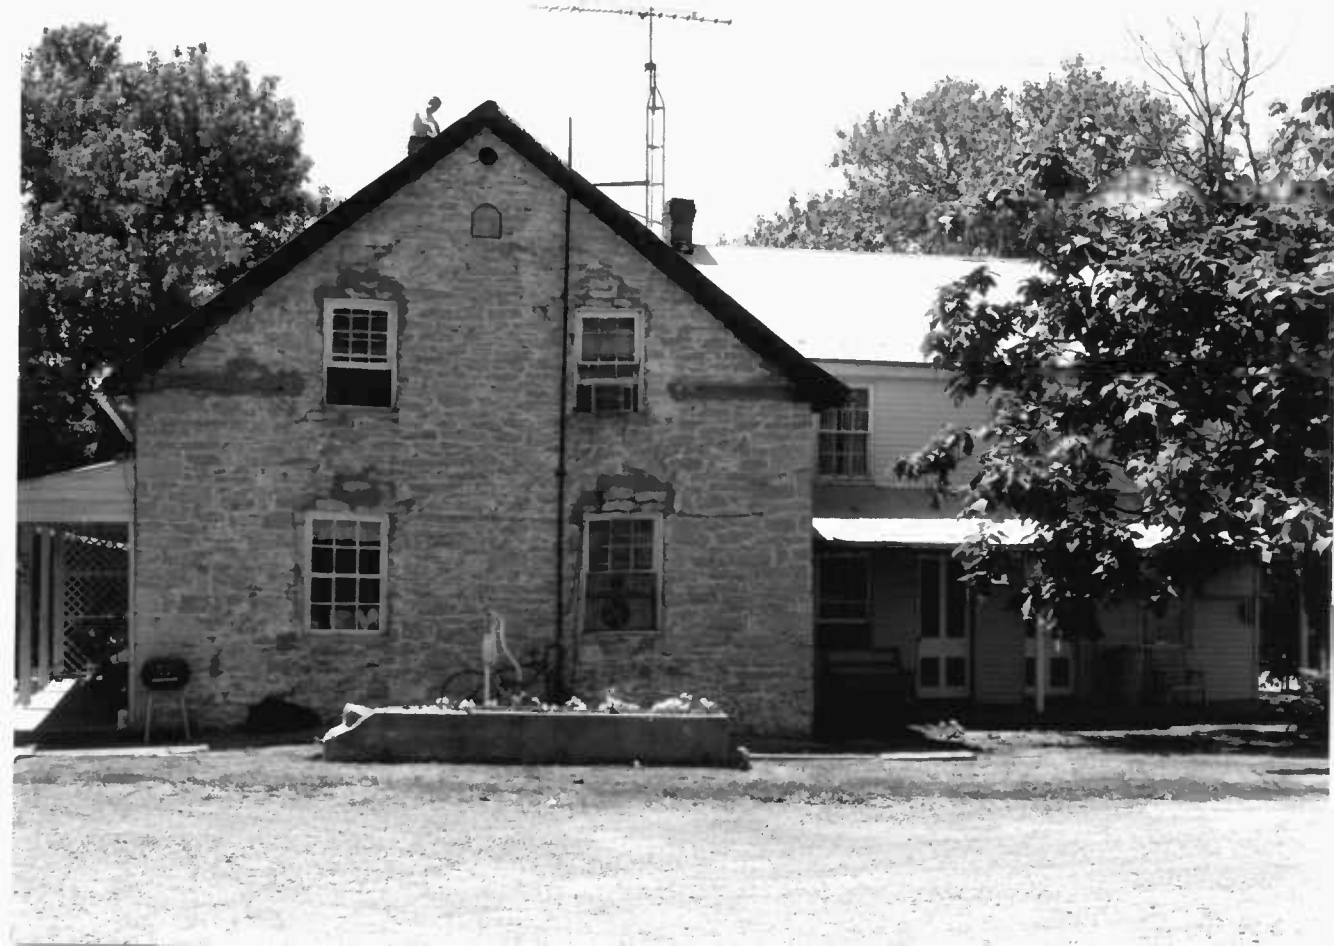
WA-1-013

Kameron's Stone House
From east

Elements on the east side of the house suggest that this was the main view greeting guests who arrived on the original road to the house. Most likely, this was a road that roughly paralleled the current US Route 11, which passes a short distance east of the Kammerer House. The east gabled wall features four evenly spaced windows, two on each story. They have been replaced with narrow frames, with some disturbed masonry around each of them. There is a round, decorative opening at

the peak of the gable, which has finely cut radiating stones around it. This opening provided light and ventilation to the attic. Beneath it is the finely executed date tablet, inscribed with the year 1774 and the initials L.K. , surrounded by an arch of finely cut stone. As on the west gable, the returns on the east are very long.
